Monitoring the quality of sewer renewal using polymeric systems in Sweden

Parastou Kharazmi

KTH Royal Institute of Technology, Brinellvagen 23, SE-100 44, Stockholm, Sweden

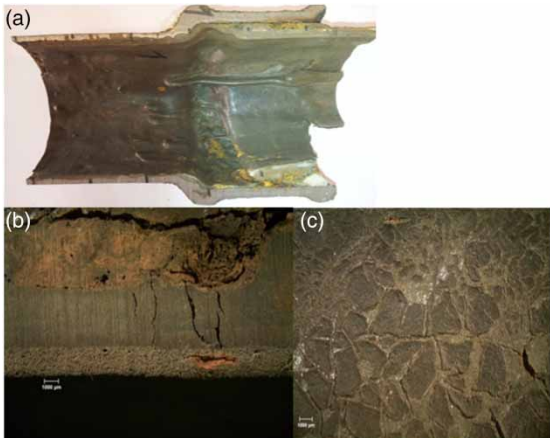
Images 1 (a), (b) and (c): sample 1.

<p>Images 1 (a), (b) and (c) – sample 1 was relined using the modified epoxy polymeric system. Defects include thickness variation and runs (1(a)), cracks (1(b)) and surface cracks (1(c)). Corrosion between the liner and host surface was also observed in some places.</p>

One of the repeated issues was uneven lining thickness – i.e., too much or too little material being applied. Excessive material application, contrary to the manufacturer's recommendations, can lead to a range of defects, including runs, which can be seen in Image 1(a) and Images 3 and 6(a).

If the dry film is too thick, this limits liner flexibility and can cause stress failure cracks – Images 1 (b) and 6 (a). The surface cracks seen in Image 1(c) – the so-called alligator defect – may also be due to excessive application. When the film is too thick, the top layer can cure faster than the rest, causing surface cracks after all the layers are cured. Small areas of excess material – see Image 6(a) – can be due to faults in the spray machine used for application.

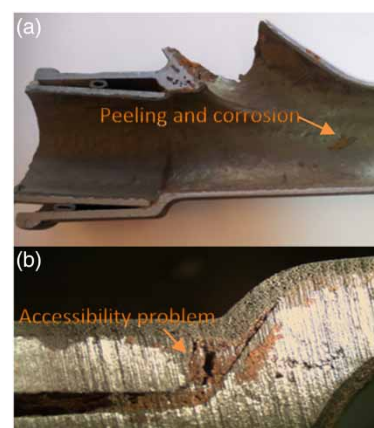
Image 2 (a) and (b): sample 2.

Images 2 (a) and (b). The pipe was relined using the modified epoxy polymeric system. Defects include liner peeling (2(a)), un-coated spots and areas without liner coverage, particularly where access was difficult (2(b)) and some corrosion.

In samples 2, 4 and 7, however, material application was inadequate in places, such that the surface cover was insufficient. Applying a uniform layer of liner can be difficult for pipe segments such as sample 2, due to its specific design and structure. The coating application was so poor in sample 4 that many areas were left without coverage – Image 4. The impregnation of material was very poor in sample 7.

Poor surface preparation can cause peeling – Image 2(a) – probably due to contamination reducing the strength and bonding inside the material, which can be pulled or flake away from between coating layers (Image 2(a)), or between the coating and the pipe – e.g., along the edges of sample 3 (Image 3). Delamination or segregation – sample 5 – probably occurs due to inadequate surface preparation.

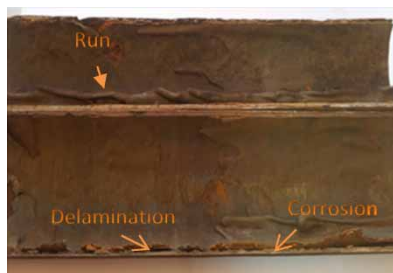
Image 3: sample 3.

Image 3. The pipe was relined using the modified epoxy polymeric system. Defects include runs, loose adhesion of epoxy lining to the host, liner delamination from the pipe, corrosion, and uneven liner film application.

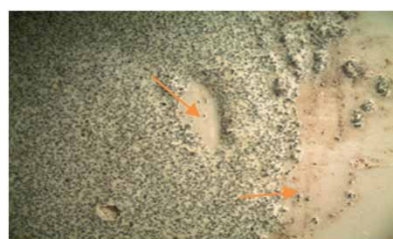
Image 4: sample 4.

Image 4. The pipe was relined using the modified epoxy polymeric system. The relined pipe was removed after only 2 weeks because the application failed, leaving a non-uniform, inadequate lining film. Many parts had no liner coverage.

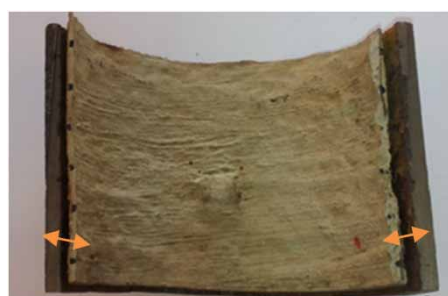
Image 5: sample 5.

Image 5. The pipe was relined using the reinforced polyester polymeric system. Defects include delamination and the lining thickness not being uniform. When the piece of pipe was cut, the lining layer came off, revealing corrosion underneath.

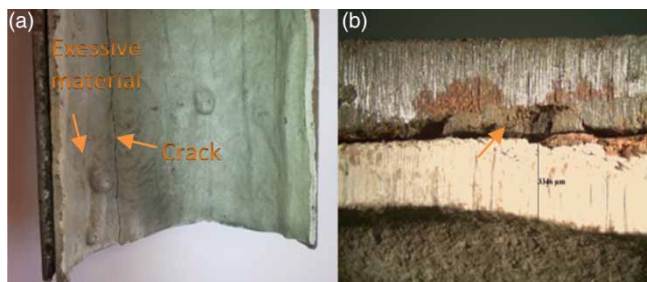
Image 6 (a) and (b): sample 6.

Images 6(a) and (b). The pipe was relined with reinforced polyester and had been in use for only seven days before being removed due to application failure and defects. The excessive film application, thickness variations and cracks can be seen in 6(a), with corrosion between the liner and host pipe (6(b)). Other defects were also observed.

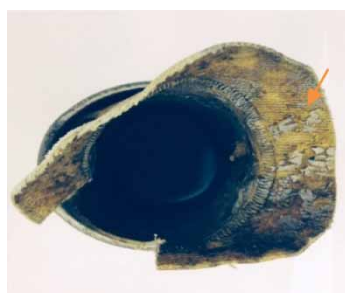
Image 7: sample 7.

Image 7. The pipe was relined using the flexible sleeve method and the sample removed shortly after installation due to the poor quality of the renovation. Impregnation of the material into the textile was very poor, as can be seen. The technical history available for the rehabilitation was insufficient to enable analysis of the cause of the issue.

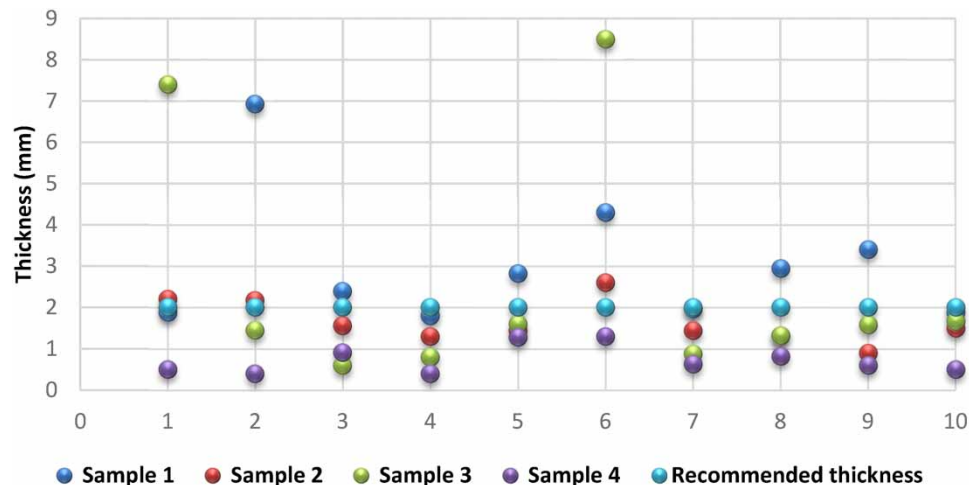
The nominal dry film thickness for liners based on modified epoxy is 2 mm, if applied in two layers, so that each layer is between 900 and 1,100 μm in thickness. For reinforced polyester coatings, the total thickness of the three layers is recommended to be 3 mm (Jotun 2016). However, thickness measurements at different places in the samples used revealed significant variation (Kharazmi 2019).

As Table 3, and Figures 1 and 2 show, the liners applied in samples 1, 3 and 6 exhibited large thickness variations.

Figure 1 | Ten thickness measurements (five points from each edge of each sample) for samples 1 to 4 (relined with epoxy) and compared with the recommended thickness.

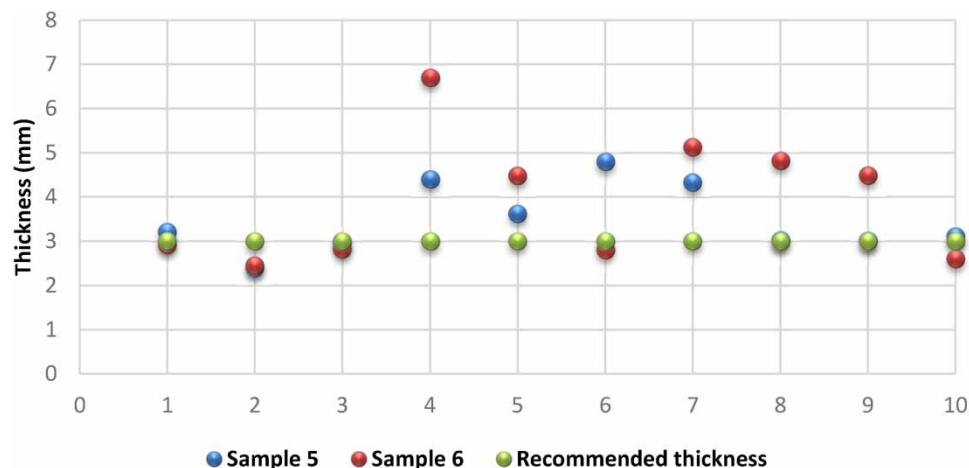
Figure 2 | Ten thickness measurements (five points from each edge of each sample) for samples 5 and 6 (relined with polyester) compared with the recommended thickness.
