Preventing the growth of iron bacteria in water wells by copper and silver coating

Georg Houben and Jürgen Sander

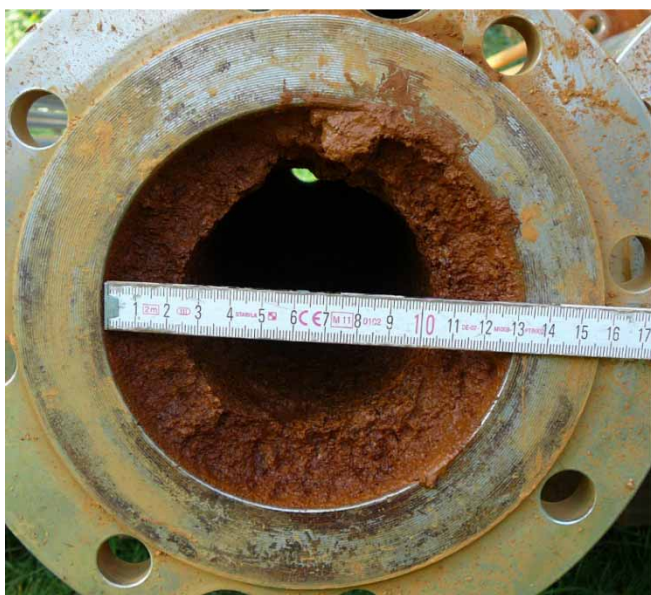
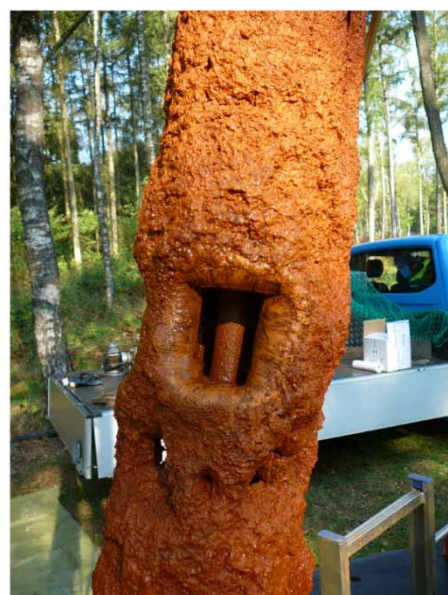
Several preventive measures, such as disinfection at regular intervals and radioactive irradiation, have been tried to subdue the growth of IRB in wells, but have met with limited success (Houben & Treskatis 2007; Menz 2016). The Großenkneten-Hagel well field of the water supply company Oldenburgisch-Ostfriesischer Wasserverband (OOWV), northern Germany (Figure 1), is a typical example of wells with IRB problems. They need to be rehabilitated on a regular basis to remove the incrustations, which involves high cost and downtimes. Figure 2 shows a typical

example of the reduction of the open area of a riser pipe from the well field after around six months of operation.

Figure 2 | Typical examples of iron oxide deposits in a riser pipe (125 mm diameter) and on a submersible pump of the Großenkneten well field after roughly six months of operation.

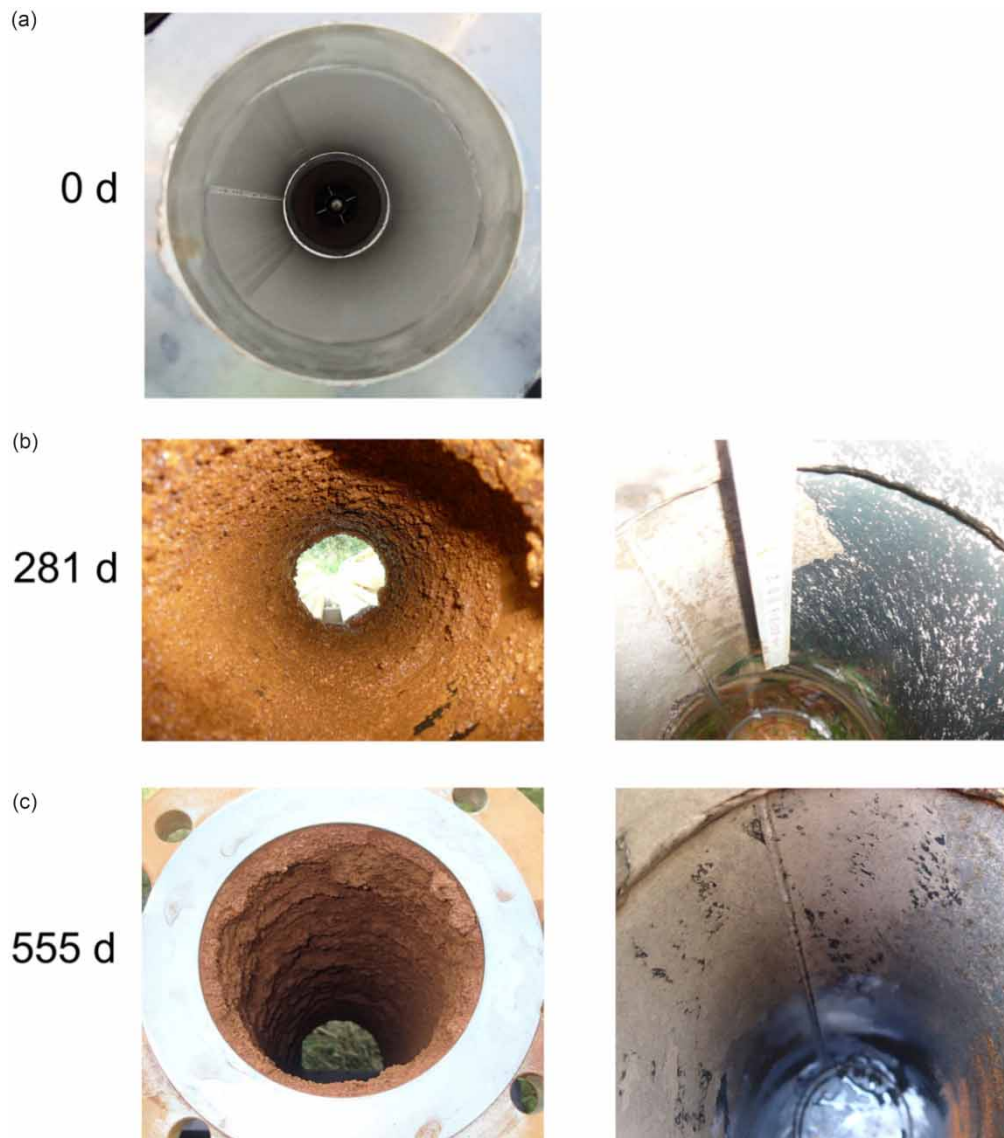
Pump and riser pipes in both wells were recovered first in September 2016, after around nine months of operation. In Well 7 (silver coating), the coating had not prevented the growth of iron bacteria and the deposition of iron oxides (Figure 4(b), left). However, the thickness of the incrustations was between 5 and 7 mm and thus significantly smaller than in the uncoated sections, which showed thicknesses of 20–30 mm, similar to what is

shown in Figure 2. In a few spots, even the original surface was visible. Higher thicknesses were observed only at the flanges, where the silver apparently did not attach well to the weld seams. The material on the silver-coated surface was significantly denser and less easy to remove than the material from the uncoated sections.

After cleaning (Figure 4(b), right), large parts of the coating were found to be missing, shown by the white color left of the centimetre scale in Figure 4(b) (right), which indicates a steel surface. To the right of the scale, the blackish coating

Figure 4 | Riser pipe of Well 7 (silver coating): (a) initial, fresh coating, (b) first inspection after 281 days, left: iron oxide incrustations on inside, right: inside after cleaning, (c) second inspection after 274 further days, left: incrustations on inside, right: inside after cleaning (photographs: Houben, Sander).

indicates that the silver had become oxidized there. The second inspection after 274 more days showed no discernible difference in the amount of incrustations between the uncoated and the silver-coated riser pipe (Figure 4(c), left). After cleaning (Figure 4(c), right), it became evident that most of the silver coating had gone, either by mechanical erosion or chemical consumption. Only small patchy blackish remnants of the silver and its nickel base layer were still visible. This explains the inefficiency of subduing the iron bacteria.

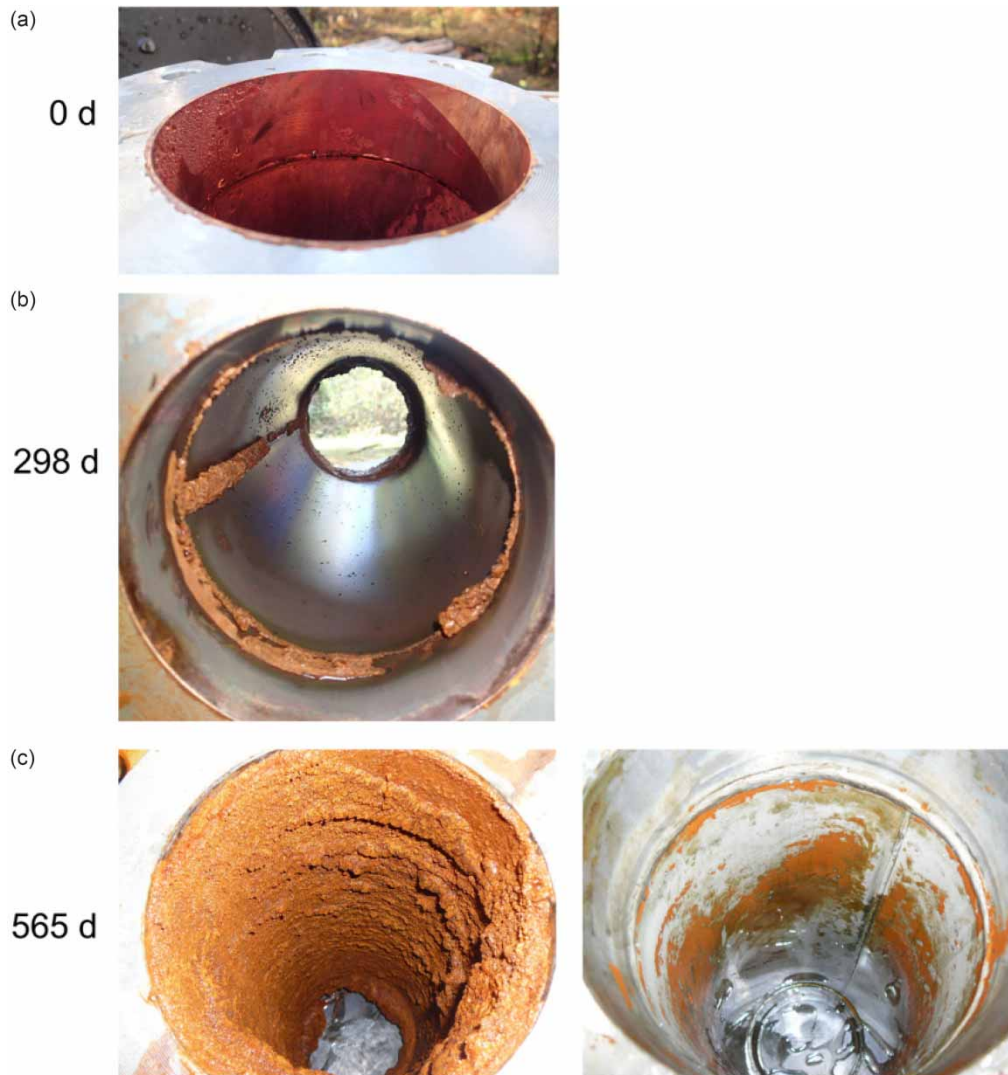
Figure 5 | Riser pipe of Well 2 (copper coating): (a) initial, fresh coating, (b) first inspection after 298 days, (c) inspection after further 267 days: (left) before cleaning, (right) after cleaning (photographs: Houben, Sander).

In Well 2 (copper coating), after 298 days, the inner pipe surface was basically free of iron oxides. The copper coating

had effectively suppressed the growth of iron bacteria and the formation of iron oxides. Incrustations were only found at the welding seams of the flanges and the pipe, where the copper apparently did not attach well (Figure 5(b)). The different surface texture or chemical composition of the seams apparently prevented the good adhesion of the copper. The copper coating showed some effects of oxidation after 298 days, as the initial metallic luster had diminished (compare Figure 5 to 5(b)).

The promising result found during the first inspection, however, could not be repeated in the second (Figure 5(c), left). The copper-coated pipe now showed a continuous

iron oxide precipitate, almost of the same thickness as in the uncoated sections. The reason for the diminished efficiency of the copper coating became clear after cleaning (Figure 5(c), right). Chemical consumption and mechanical erosion had removed most of the coating and only patches of a greenish taint, probably oxidized copper or nickel, remained (the orange patches in Figure 5(c), right, are iron oxides).

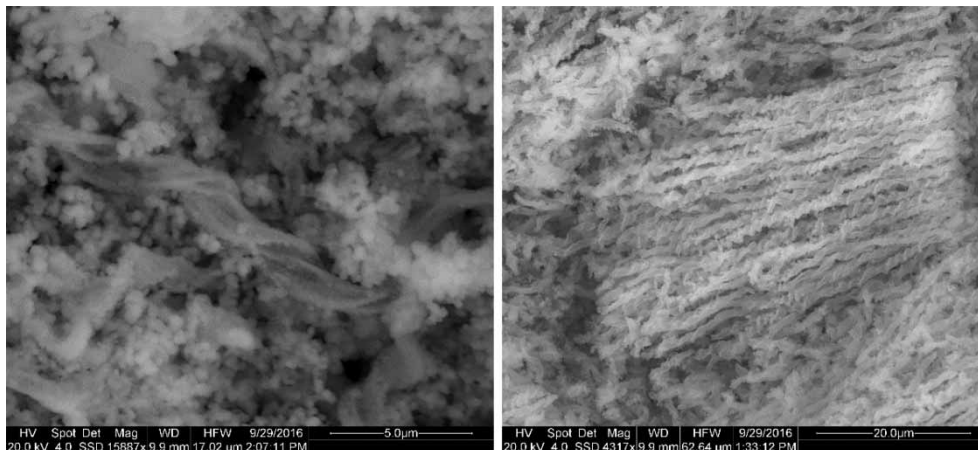
Under the electron microscope, the iron oxide precipitate sample from the uncoated riser pipe of Well 7 shows a variety of shapes (Figure 6(a)), from dominant very small

(<1 µm) cell-shaped aggregates to some interspersed twisted stalks of the iron-oxidizing bacterium *Gallionella ferruginea*. The genetic analysis shows a very diverse composition, consisting of various species with different metabolisms, iron oxidation (*Sideroxydans*, *Geothrix*), sulphur oxidation (*Sulfuricurvum*), methane (*Methylobacter*) but also raptor bacteria such as *Bacteriovorax*, indicating an active and complex biofilm. The iron oxidizer *Sideroxydans* is the predominant species (52.6%).

The sample from the silver-coated pipe of the same well is dominated by bundles of *Gallionella* stalks of 40–100 µm length under the electron microscope (Figure 6(b)). Other shapes are less abundant. The genetic analysis shows a composition similar to that of the uncoated riser pipe. However, the iron oxidizers are more abundant here, compared with samples from uncoated surfaces, confirming the visual observation above. *Sideroxydans* is the most abundant species (64.3%). This could indicate a competitive advantage of stalk-building IRBs over non-stalk-building bacteria. Maybe the former can use the stalks to outgrow the toxic surface, while the latter are attached directly to the toxic surface and thus are more prone to the microbicidal effect.

Figure 6 | Electron microscopy pictures of iron bacteria (a, left) from the uncoated and (b, right) from the silver-coated riser pipe from Well 7.

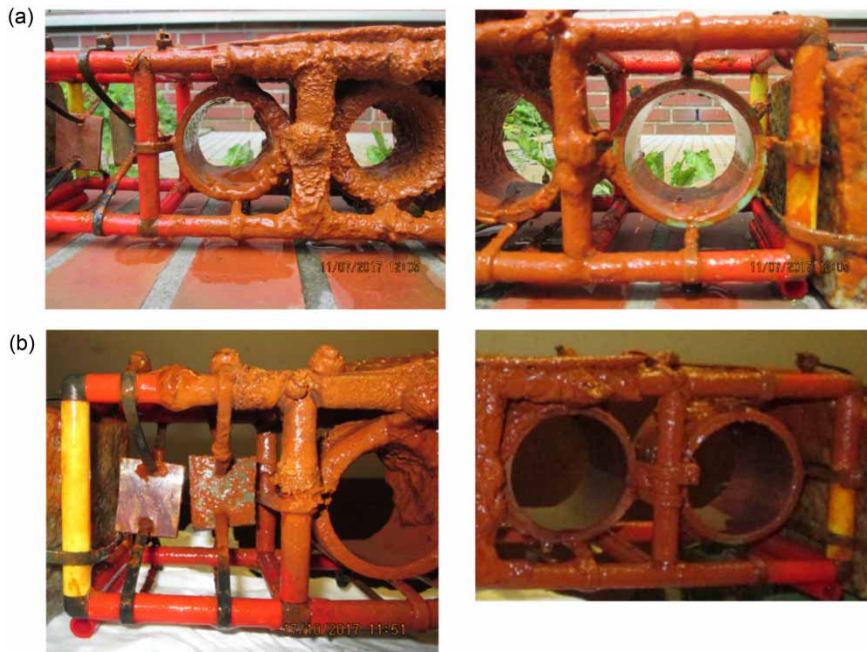
Figure 7 | Sample holder recovered (a) after one month: (left) from left to right: metal coupons (no clogging, little oxidation), PVC blank and spray-coated PVC (high degree of clogging), (right) galvanised and foil-coated PVC (partially clogged), (b) after four months: (left) metal coupons (partially clogged and oxidized), PVC blank, (right) galvanised and foil-coated PVC (clogged and coating eroded).

deposits. The polished copper coupon showed strong oxidation effects, including a green patina, resembling the initial state of the unpolished coupon. Surprisingly, the copper spray paint was still present, although strongly oxidized. In the galvanised PVC tube, only small oxidized copper patches remained, covering roughly 25% of the original surface. In the foil-coated tube, about 60% of the tape was still present, with the copper cover heavily oxidized.

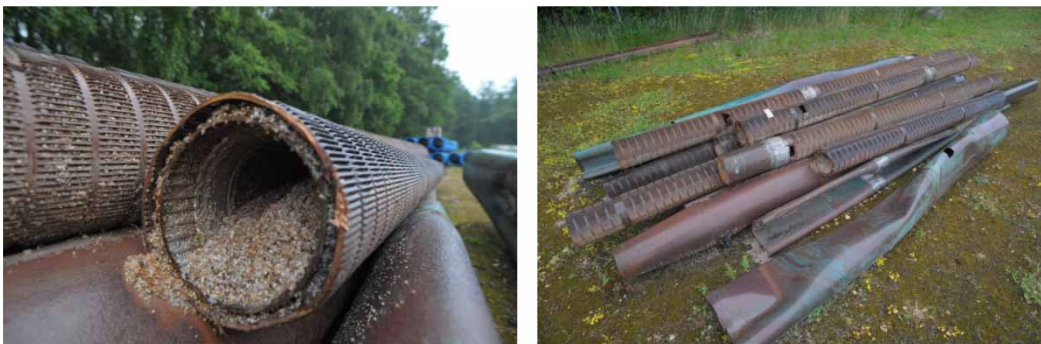
In Well 29, where the casing and screen were pulled during reconstruction, the recovered pipes and the screen slots were remarkably clean (Figure 8), especially when compared with pictures from other reconstructions of old wells (Houben & Treskatis 2007). The relative indifference of the copper wells to iron oxide clogging was often attributed to favorable local hydrochemical conditions and overshadowed by their mechanical deficiencies, which even required the insertion of a wire-wound screen to prevent a collapse.

Figure 8 | Pictures of recovered copper screen (150 mm diameter, with stainless steel wire-wound screen insert) and casing from Well 29, Wildeshausen (photographs: Sander).
