Formation and prevention of pipe scale in water supply pipelines with anti-corrosion lining

Key words: anti-corrosion lining, pipe scale, prevention, water supply pipelines

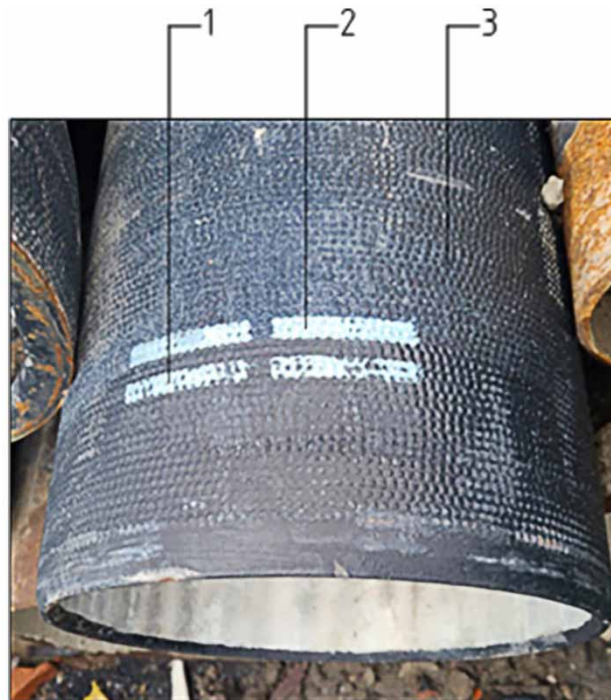
Figure 8 | Marking Line for the Socket of Socket and Spigot Connected Cast Iron Pipes. 1-The first marking line of the socket 2-The second marking line of the socket 3-Pipe socket.

(a) Strict inspection of the anti-corrosion layer on the connection surface of the socket and the mouthing before pipeline laying is necessary. If a defect is found in the anti-corrosion layer, it should be timely repaired. (b) The length of the top mouthing into the socket during pipeline laying should be strictly controlled so that the connection surface of the socket and the connection surface of the mouthing does not collide. When the pipeline is newly laid, the length of the socket inserted into the mouthing should reach the first marking line of the socket; if it reaches the second marking line, it is a warning (see Figure 8). When the marking line is not seen, it has been inserted too far. The socket should be removed from the socket and the connection surface between the socket and the mouthing checked for any damage. If it is damaged, it should be rehabilitated in time according to the specification.
