An effective measure for evaluating sewer condition: UAV screening in comparison with CCTVs and manhole cameras

Key words: asset management, operator safety, pipe inspection, screening, UAV

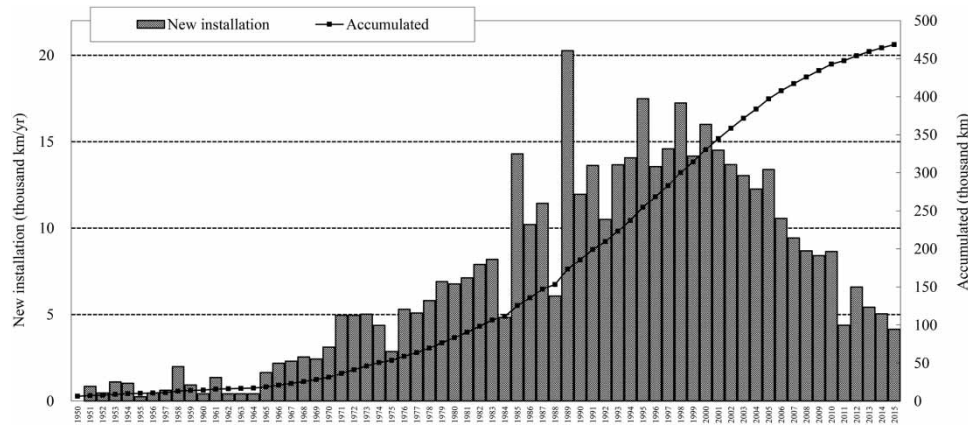
Figure 1 | New sewer construction and accumulated length by year (Japan Sewage Works Association 2015)

The majority of sewers in Japan were constructed after the 1970s. In 2017, sanitation coverage reached approximately 80%. Along with the growth of coverage rate, the sewer stock has grown steadily, reaching approximately 470,000 km in the recent statistics (Figure 1).

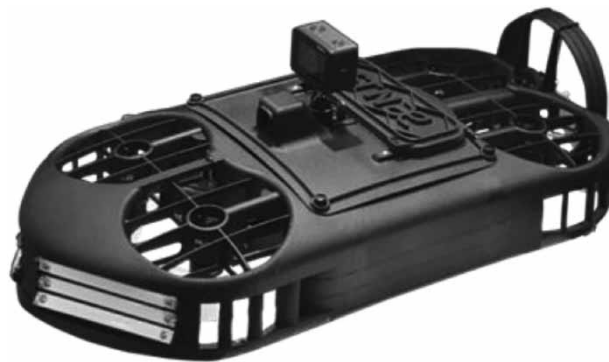
Figure 2 | Appearance of the UAV.

specification of the UAV can be found in [Table 1](#) and its appearance in [Figure 2](#). This model was jointly developed by NJS and Autonomous Control Systems Laboratory Ltd. (ACSL), a Japanese UAV company.

Weight	1.5 kg (includes a Li-Po battery)
Size	W:250 mm, L:570 mm, H:120 mm
Flight duration	Approx. 5 min
Flight speed	0.5–3 m/sec
Camera	SONY DSC-RX0
Resolution (video shooting)	Approx. 2,000,000 pixels
Viewing angle	84°

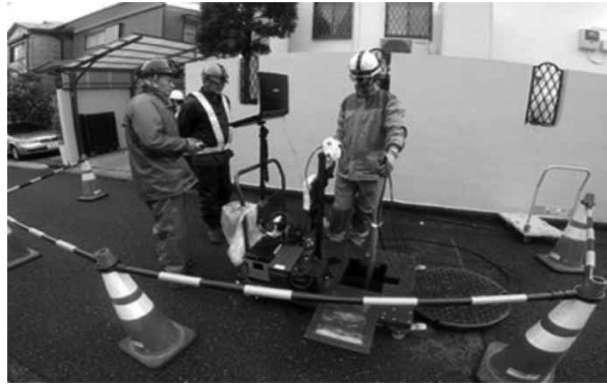
Figure 4 | Operators working from above ground in UAV inspection.

The index for the operator's safety was set to be the number of manhole openings that operators had to enter. The numbers were CCTV = 30 openings, manhole camera = 0 opening and UAV = 1 opening. The one opening recorded for UAV had happened when the operator misguided the UAV to a deep gap and had to enter the manhole to retrieve it. This could have been prevented by examining the construction drawings prior to the inspection. Basically, an inspection by UAV was able to carry out the whole process from above ground, including preparation, inspection and clean up (Figure 4).
