## Water quality impacts of young green roofs in a tropical city: a case study from Singapore

This study examined the effects of two substrates (SOIL and COMMERCIAL) and grass on the green roof runoff quality in Singapore. Ten events were sampled over a 9-month period. Rainfall and green roof runoff from grass and bare experimental configurations were tested for total organic carbon (TOC), nitrogen and phosphorus nutrients ( $\text{NO}_3^-$ -N and  $\text{PO}_4^{3-}$ -P), cations/anions and trace metals (Fe, Cu, Zn, Cd and Pb). All configuration units neutralised acid rainfall and removed metals except Fe despite their proximity to an industrial area. Concentrations decrease over the monitoring period for most water quality variables. The COMMERCIAL (COM) configurations elevated  $\text{Cl}^-$  (3.8–10.8 ppm),  $\text{SO}_4^{2-}$  (1.5–32.4 ppm),  $\text{NO}_3^-$ -N (7.8–75.6 ppm) and  $\text{NH}_4^+$ -N (22.0–53.1 ppm) concentrations in the runoff. Concentrations of  $\text{NO}_3^-$ -N (4.5–67.7 ppm) and  $\text{NH}_4^+$ -N (14.7–53.0 ppm) remained high at the end of the monitoring period for the COMgrass configuration, even with dilution from monsoon rainfall, making it suitable

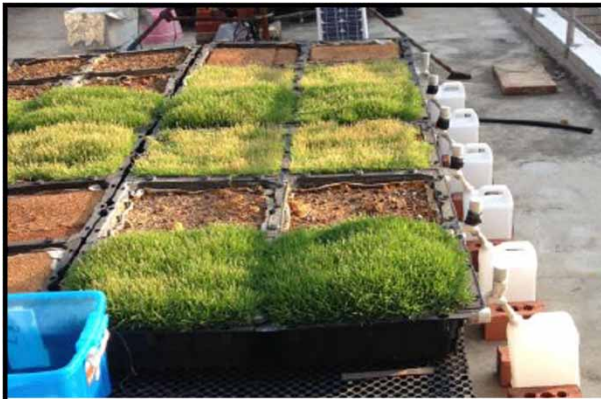
## GRAPHICAL ABSTRACT

Green roofs removed trace metals and neutralised acid rainfall.

Substrate low in organic matter suitable for widespread implementation in Singapore.

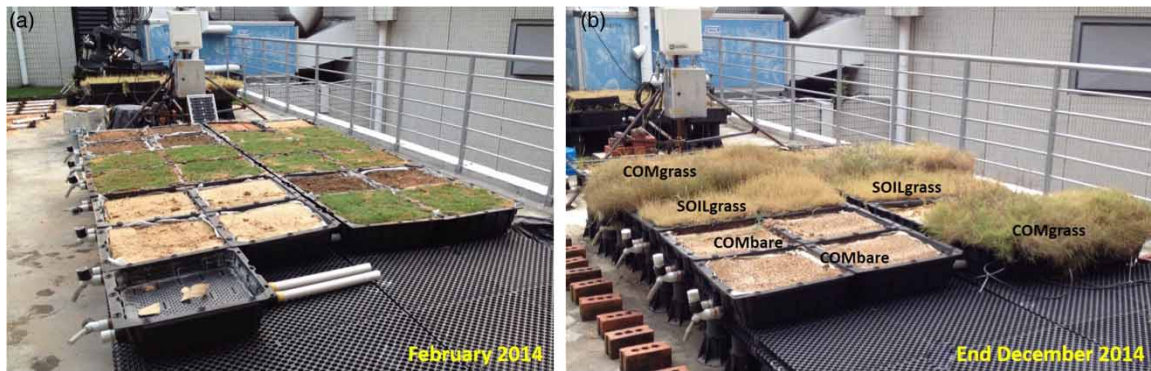
**Figure 5** | The green roof design configuration units in (a) February 2014 and at the (b) end of the monitoring period showing that grass is well established on the configuration units.
