Assessment of a membrane drinking water filter in an emergency setting

The performance and acceptability of the Nerox[™] membrane drinking water filter were evaluated among an internally displaced population in Pakistan. The membrane filter and a control ceramic candle filter were distributed to over 3,000 households. Following a 6-month period, 230 households were visited and filter performance and use were assessed. Only 6% of the visited households still had a functioning filter, and the removal performance ranged from 80 to 93%. High turbidity in source water (irrigation canals), together with high temperatures and large family size were likely to have contributed to poor performance and uptake of the filters.

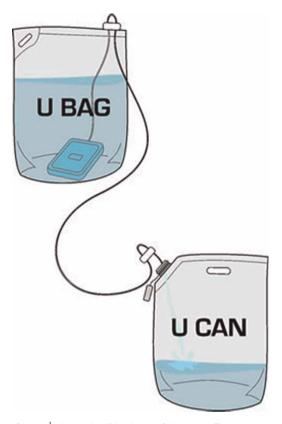
The NeroxTM filter (A-Aqua, Oppegaard, Norway) is a gravity water filter system (Figure 1) that employs a $0.28 \,\mu m$

Figure 1 | Diagram describing the use of the Nerox™ filter.

membrane to mechanically remove bacteria, cysts and helminths from water of unknown microbial quality. Although different websites make claims about the removal performance of E. coli, total coliforms, faecal coliforms, Salmonella spp., metals, certain organic compounds found in fertilizers, herbicides and pesticides, the official website makes no claims regarding treatment performance. In so far as the Nerox[™] filter employs microfiltration, it also reduces turbidity, thereby improving the water's appearance. The membrane is contained in a hard plastic housing measuring $20 \times 16 \times 2.5$ cm. Source water passes into the housing and through the surface of the membrane; product water is delivered via a 1.95 m plastic tube. The basic filter unit, identified as the 'Nerox-02' consists of the housing, membrane, tube, sponge for cleaning the membrane surface, and stopper. In this evaluation the basic filter was accompanied by two collapsible water containers (a 15litre 'U-Bag' bag for raw source water and a 10-litre 'U-Can' bag with cap for the treated drinking water), a small hand pump for establishing flow, a screw cap and two tube clips (the 'Nerox-2 emergency drinking water kit', product no. 5800-5). The filter assembly has to be placed inside the raw water container, which has to be placed a minimum of 30 cm higher than the drinking water container.

Households have to start the filtering process by pumping the air from the tube to create a siphon. When flow has been established, the end has to be placed into the product water container. Based on the manufacturer's instructions, the membrane has to be cleaned every 3–7 days by stopping the flow, opening the membrane housing, filling the raw water vessel with treated water, and gently wiping the membrane on both sides with the sponge provided. The cleaning instructions also recommend that water containers are disinfected and that the filter system is cleaned by filtering 8 to 10 litres of chlorine-treated water through the membrane filter. It has been claimed that the capacity of the membrane is 2,000 to a maximum of 2,500 litres; however, that would depend on the quality of the raw water. The flow rate was described in the
